End-of-Life Evaluation of Compressed Natural Gas Vehicle Fuel Tanks

Aaron Williams and Lauren A. Lynch

National Renewable Energy Laboratory

Technical Report
NREL/TP-5400-80446
July 2021

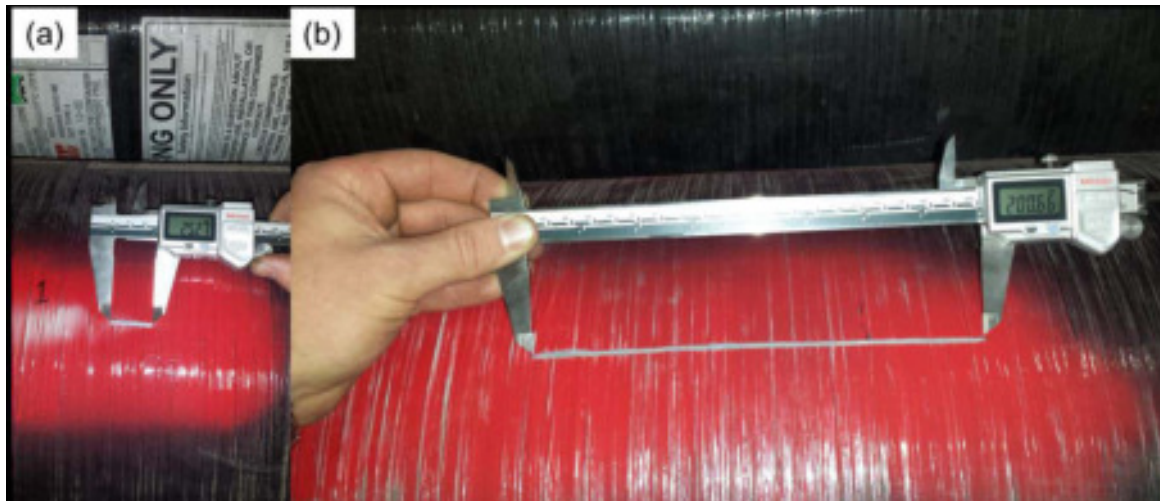
Figure 3. (a) Representative short notch with deep depth and (b) representative long notch with shallow depth

Eight of 20 artificially damaged tanks were notched before pressurized until burst. Two notches were imposed along the axial direction of four Type III cylinders and four Type IV cylinders according to Section A.17 of ISO 11439. One notch was shorter in length with a deeper depth, and the second notch was longer in length with a shallower depth. The shorter notch was 1.0 inch long and 0.05 inches deep, whereas the longer notch was 8.0 inches long and 0.03 inches deep, as show in Figure 3.

After the eight tanks—four Type III and four Type IV—were artificially damaged via notching, they were subjected to MAE examination. None of the eight tanks passed the acceptance criteria and would have been denied for continued use. MAE examination confirmed that a stress concentrator had been introduced into each composite cylinder’s microstructure and that the tank’s burst strength was degraded as compared to an undamaged cylinder. A summary of the MAE examination results and the identified specific cause of rejection is shown in Table 9.

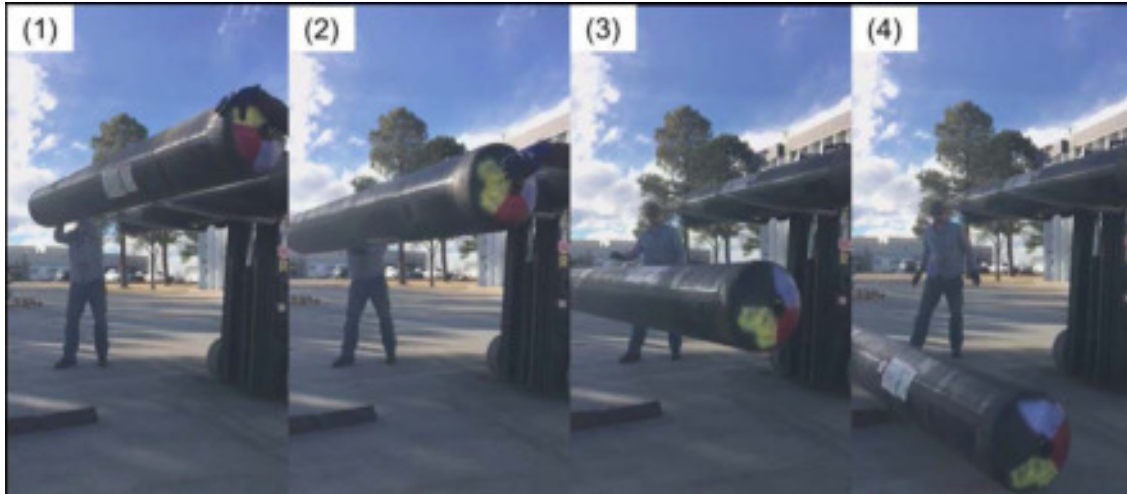
Figure 4. (1) Tank at testing height; (2) drop initiation of the tank; (3) tank dropping; (4) impact of the tank onto the steel angle iron

Twelve of the 20 CNG fuel tanks were artificially damaged through horizontal impact events as defined in Section A.20 of ISO 11439. Four of the tanks—two Type III cylinders and two Type IV cylinders—were subjected to impact damage as specified in the test procedure by dropping the tanks from the specified height onto a flat concrete surface. In order to represent a worst-case scenario of real-world failure modes of impact damage experienced by CNG fuel tanks in service, the remaining cylinders were dropped onto a modified surface from an adjusted height from that defined in the test procedure. Two Type III and two Type IV fuel tanks were dropped onto a 4 in. x 6 in. x 36 in. piece of angled steel located on the ground at the impact location. The angled steel localized the impact onto the tank to increase the severity of the damage. Another two additional Type III and two Type IV fuel tanks were dropped from twice the defined height onto a 4 × 6 × 36-in. piece of angled steel located on the ground at the impact location, as the increased height from which the tanks were dropped doubled the amount of potential energy of the impact event. These modified test conditions were a better representation of severe damage inflicted onto CNG fuel tanks in actual operating environments. Figure 4 depicts a time lapse of the representative localized impact event onto the steel angle iron.

After the 12 tanks (six Type III and six Type IV) were artificially damaged via impact, they were subjected to MAE examination per in Section A.20 of ISO 11439. MAE evaluation was conducted directly after the impact events, prior to additional fatigue or burst testing. Four Type III tanks passed the MAE examination: two with impact damage inflicted per ISO 11439 and two with localized impact damage as inflicted per the modified procedure with an angled steel iron. Two Type IV tanks passed the MAE examination, both with impact damage inflicted per ISO 11439. MAE examination confirmed that a stress concentrator had been introduced into the six other composite cylinder's microstructure and that the tank's burst strength was degraded as compared to an undamaged cylinder. The four Type III and two Type IV tanks that passed the MAE examination also passed the burst pressurization test. The fatigue and burst tests that followed the MAE examination of the impacted tanks confirmed that the MAE criteria were valid predictors of which tanks experienced degraded structural integrity and ultimately failed the following burst pressure test. A summary of the MAE examination results of the impacted tanks and the identified specific cause of rejection is shown in Table 10.
