January 4, 2022

Safety Notice – Cylinder Collar Fatigue in Mainstay CNG Modules

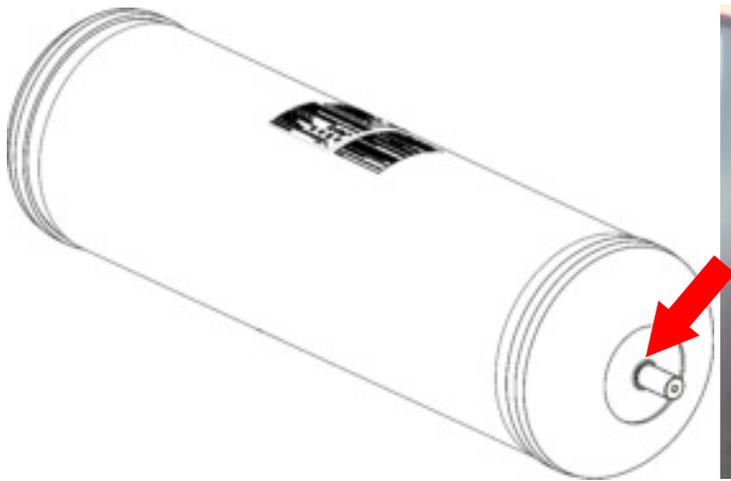
Figure 1a

CNG fuel system inspectors should be advised that evidence of collar fatigue may not be visible to the naked eye unless the damage is severe and the CNG cylinder has already experienced a loss of containment. Lengthy evaluation of the failure mode in this case resulted in determination that special equipment is required to ensure CNG cylinder integrity. Therefore, this advised cylinder inspection process should include Modal Acoustic Emission (MAE) testing to detect damage at the base of the cylinder's metal collar where it interfaces with the liner (see Figure 1). This testing and evaluation should provide the customer with a safe and reliable method to confirm integrity of the collar and the cylinder as a whole.

It is advised that any motor vehicle with a Mainstay CNG module on board undergo immediate cylinder inspection by a certified CNG fuel system inspector. This action is recommended regardless of timing since the last inspection.

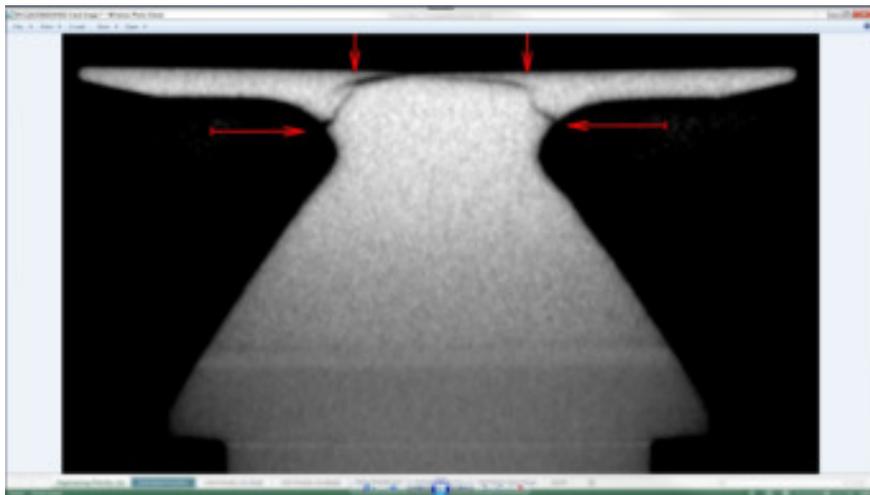
Figure 2

Identifying collar fatigue cracks at the base of the cylinder's metal slip collar where it interfaces with the liner is critical for mitigation of this failure mode. MAE testing has been proven to be a reliable, nondestructive inspection method that allows owners of Mainstay modules to inspect the condition of their module systems and detect fatigue cracks such as those identified in test results (see Figure 2).

NOTE: CNG cylinder manufacturers should always be consulted as part of testing and analysis of results in special circumstances such as this. Mainstay modules are configured with different cylinder makes, and the respective manufacturer should be contacted before any final determination is made regarding evaluation, repair, or replacement.
